TREE SURVEY REPORT

**Site Address: Falmouth Cemetery, Pennance Road,
Falmouth, Cornwall**

Client: Falmouth Town Council

Dated: 15th December 2021

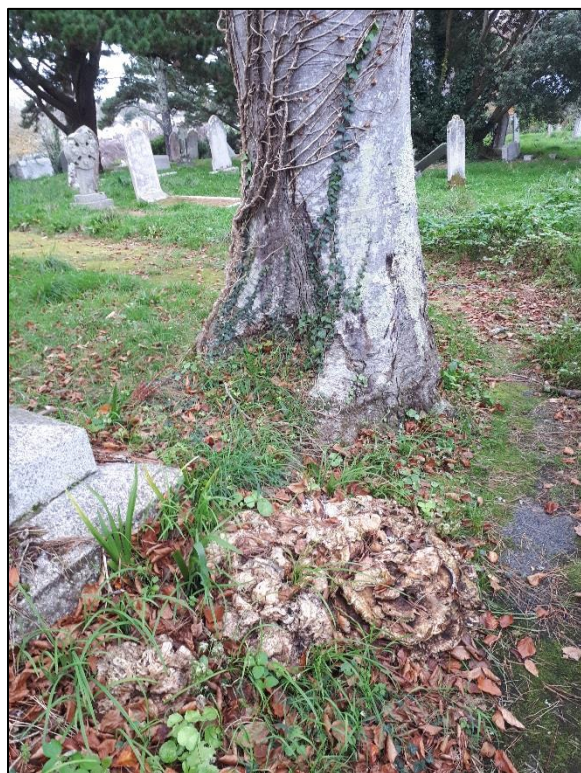
Tree / Tag No	Species	Age	Size	Condition	QTRA Fields (Target, Size, PoF)	QTRA Outcome	Works Specification	Cat
1000	Beech (Fagus sylvatica)	E/M	L	<ul style="list-style-type: none"> Fungal Fruit Bodies – Roots: Meripilus gigantea, SE side, 1m from stem base. See Fig 1. Exudate: suspected Honey Fungus, bark death and lesions E & S side from gl to 1.4m gl+. See Fig 2. Crown exhibits even bud distribution. 	3/1/3 2/prop/3	40K root failure onto highway 30K tree failure onto third party property to E	<ul style="list-style-type: none"> Remove 	
1001	Horse Chestnut (Aesculus hippocastanum)	M	L	<ul style="list-style-type: none"> Exudate: suspected Honey Fungus. Stem: dead. Dead bark with white mycelium around entire stem circumference – see Fig 3. Stem disorder: Bleeding Canker of Horse Chestnut. 	3/prop/3 2/3/3	30K branch / stem failure onto parked cars branch / stem failure onto highway	<ul style="list-style-type: none"> Remove.

Fig 1. Tree 1000 *Meripilus giganteus*

- 5.1.2 Meripilus is known to decay woody roots, initially decaying the underside of the root but being largely confined to the roots / buttresses and not the stem base. The mode of decay is a white rot or in the early stages a soft rot which can result in brittle fracture of degraded roots.

- 5.1.3 I have experienced whole tree failure where Meripilus has been present. To ensure that tree risk is considered proportionately, it is necessary to understand the target areas and risk exposure from whole tree failure. In this case, Tree 1000 is within a theoretical strike range of multiple targets and removal has been recommended based on the risk assessment outcomes.

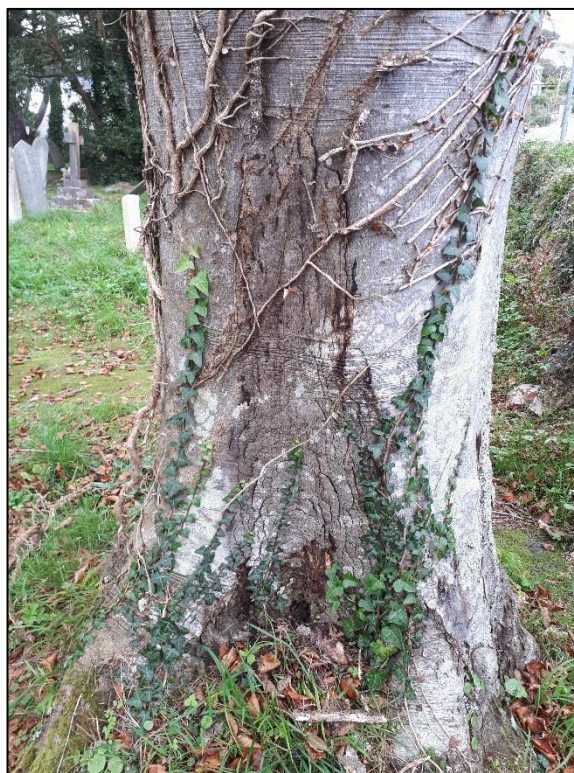
Fig 2. Tree 100 bark bleeding

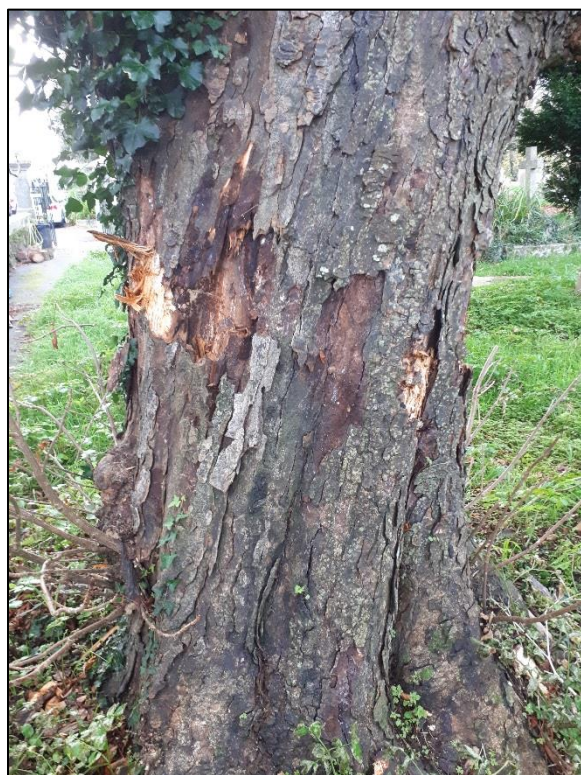
Fig 3. Tree 1001 stem bark death

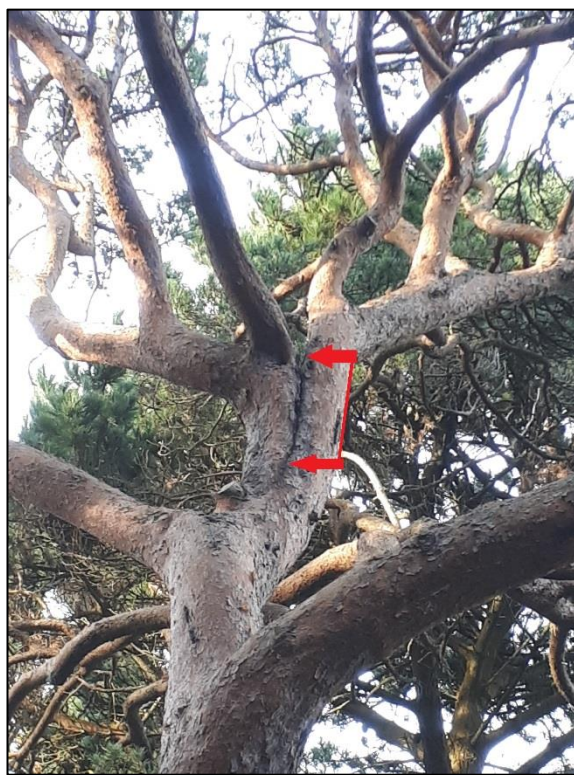
1002	Scots Pine (Pinus sylvestris)	M	L	<ul style="list-style-type: none"> Central stem splitting longitudinally at junction 10m gl+. See Fig 4. 	4/3/2	500K stem failure onto path	<ul style="list-style-type: none"> No works required 	
1003	Small Leaf Lime (Tilia cordata)	E/M	L	<ul style="list-style-type: none"> Basal epicormics. Leaning tree orientation: SE. Previously topped 8m gl+. 			<ul style="list-style-type: none"> Remove epicormics. 	iv
1004	Scots Pine (Pinus sylvestris)	E/M	M	<ul style="list-style-type: none"> Dead secondary stem on W side failed and propped on E side of crown at 8m gl+. See Fig 5. 	4/prop/3	300K stem failure onto gravestone	<ul style="list-style-type: none"> Remove large diameter deadwood. 	iv
1005	Prunus Kanzan	M	M	<ul style="list-style-type: none"> Stem: Ivy restricted inspection. Stem disorder: Bacterial Canker Cherry. Branches: large cankers visible on multiple branches. Major deadwood >25mm: small volumes through crown. Crown dieback in upper, N side. 	4/4/2	<1M deadwood failing onto path	<ul style="list-style-type: none"> Sever ivy. Remove large diameter deadwood. 	ii

Fig 4. Tree 1002 stem splitting

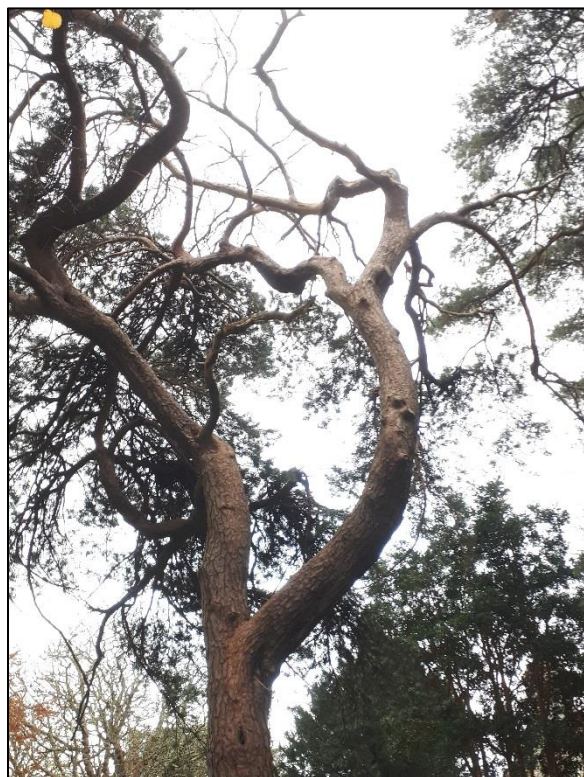
Fig 5. Tree 1004 dead stem

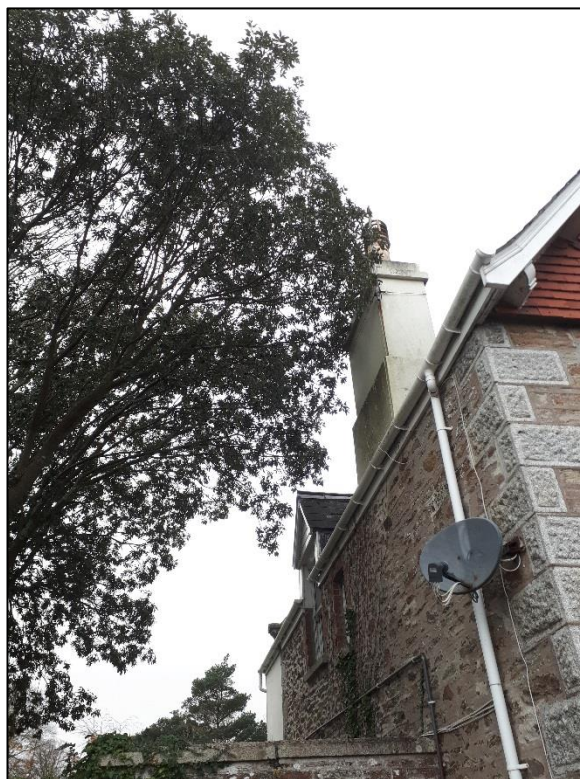
<ul style="list-style-type: none"> Branches: In contact with chimney stack. See Fig 6. 			<ul style="list-style-type: none"> Prune to clear structure by 2m. 	iii
G4	Grey Willow (<i>Salix cinerea</i>)	Y	M	<ul style="list-style-type: none"> Likely to damage gravestones. 			<ul style="list-style-type: none"> Remove. Treat stumps - approved chemical treatment. 	iii
G5	Douglas Fir (<i>Pseudotsuga menziesii</i>)	Y	M	<ul style="list-style-type: none"> Roots damaging hard surfaces. Stem: tight fork / forks. Branches: crossing / rubbing branches; branch stubs. Broken hanging branches: 2nd tree from E side. 4-6m N side, 80mm diameter, propped, shortened. 10m gl+, N side, 30mm diameter, attached. Crown: minor deadwood <25mm; yellowing needles. Central tree, N side. See Fig 9. 	3/4/3	<1M branch failure onto path	<ul style="list-style-type: none"> Monitor crown vitality and any progression in discolouration 	iv

Fig 6. G3 proximity to structure

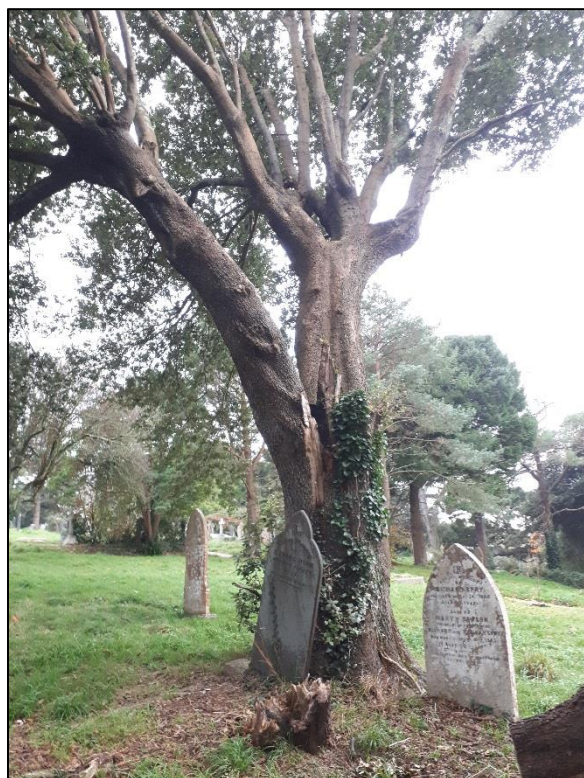
1007	Holm Oak (Quercus ilex)	M	L	<ul style="list-style-type: none"> Previously topped: 4-5m. 14.2m in height. Stem: secondary stem failure at 2.3m gl+ on NE side. See Fig 7. 	4/prop/3	300K stem failure onto bench and gravestones	<ul style="list-style-type: none"> Re-pollard to 300mm above existing pollard heads. 	ii
					4/3/3	<1M stem failure onto path		
1008	Scots Pine (Pinus sylvestris)	Y	M	<ul style="list-style-type: none"> Stem: Ivy restricted inspection. 			<ul style="list-style-type: none"> Sever Ivy. 	iv
1009	Common Ash (Fraxinus excelsior)	Y	M	<ul style="list-style-type: none"> Crown: ADB symptoms - dead epicormics and tip dieback. Winter 2022 	3/4/2	500K deadwood failing onto highway	<ul style="list-style-type: none"> Monitor for ADB symptoms summer 2022. Remove with progressive decline 	iv
1010	Monterey Pine (Pinus radiata)	M	L	<ul style="list-style-type: none"> Roots: unidentified fungal fruiting body, W side by recess in stem base. White spore print and surface. Yellow-brown to buff internal. Possibly in leaf litter. See Fig 8. Stem: Ivy restricted inspection. Crown: crown showing normal foliage density for the species. Major deadwood >25mm: small volumes through crown. 			<ul style="list-style-type: none"> Sever Ivy. Monitor for fungal fruiting bodies as part of routine site maintenance. 	ii

Fig 7. Tree 1007 failed pollard head

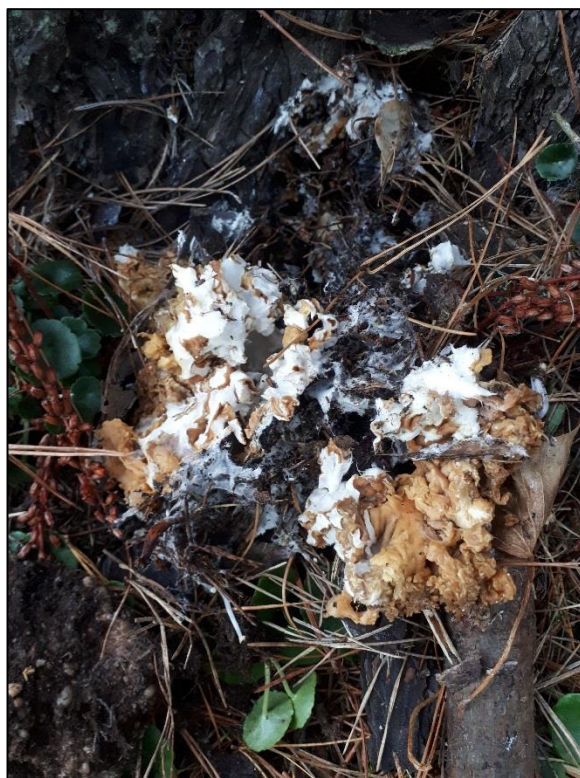
Fig 8. Tree 1010 unidentified fungi

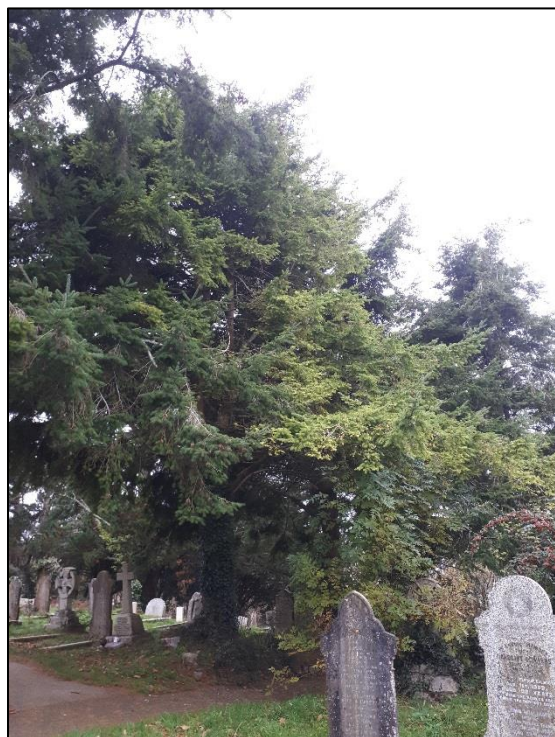
Fig 9. G5 canopy yellowing

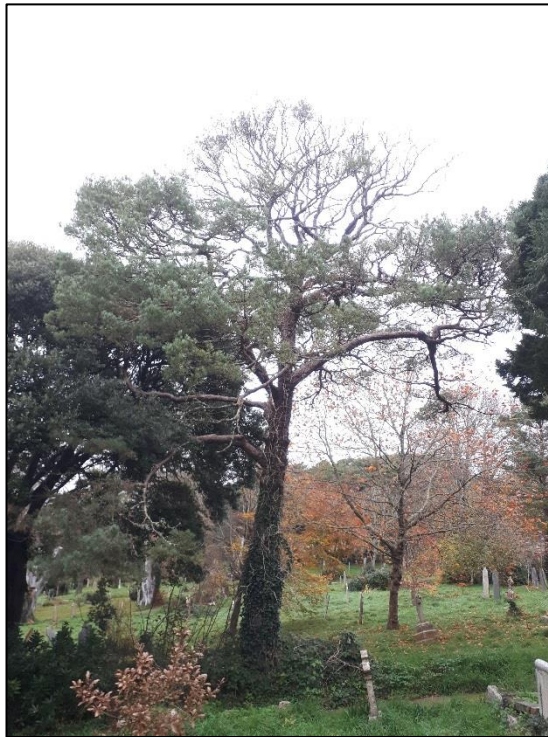
Fig 10. Tree 1014 declining Scots Pine

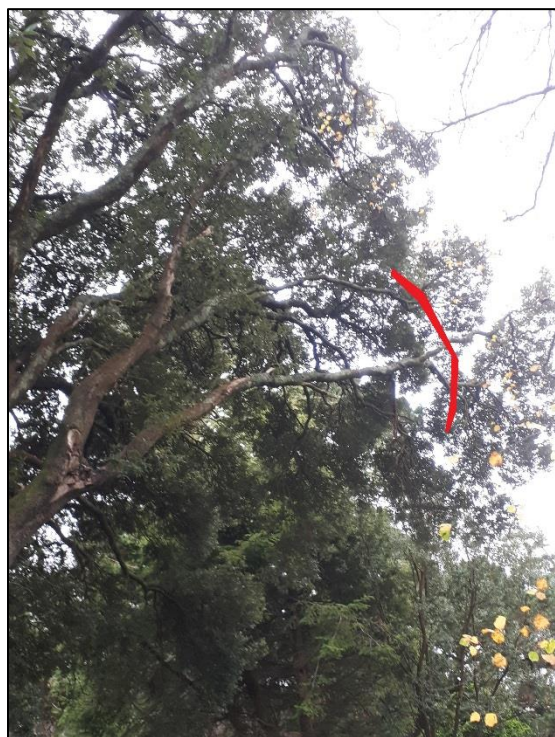
Fig 11. Tree 1015 crown reduction (red)

<ul style="list-style-type: none"> Major deadwood >25mm: small volumes through crown. 				
1012	Holm Oak (Quercus ilex)	Y	M	<ul style="list-style-type: none"> Stem: central stem split longitudinally from 2.5m to 1m gl+. Broken hanging branches: 3m gl+, E side, failed stem propped in centre of crown. 4m E side, hung up. 	4/prop/3	300K stem failure onto gravestone	<ul style="list-style-type: none"> Coppice. 	iv
1013	Blue Atlas Cedar	Y	M	<ul style="list-style-type: none"> Stem: Ivy restricted inspection. 			<ul style="list-style-type: none"> Sever Ivy 	iv
1014	Scots Pine (Pinus sylvestris)	M	M	<ul style="list-style-type: none"> Stem: Ivy. Crown: small / sparse foliage; crown retrenching see Fig 10. Major deadwood >25mm: large volumes through crown. 	3/4/3	<1M deadwood failure onto path	<ul style="list-style-type: none"> No works required 	
1015	Holm Oak (Quercus ilex)	M	L	<ul style="list-style-type: none"> Dead bark - orientation and dimensions: S stem, 2.2-3.5m gl+, NW facing. Stem: stem failure, W side, 4m gl+ at union. 	4/prop/3	300K stem failure onto gravestone	<ul style="list-style-type: none"> Reduce failed stem by 2m as per photo Fig 11. 	iv

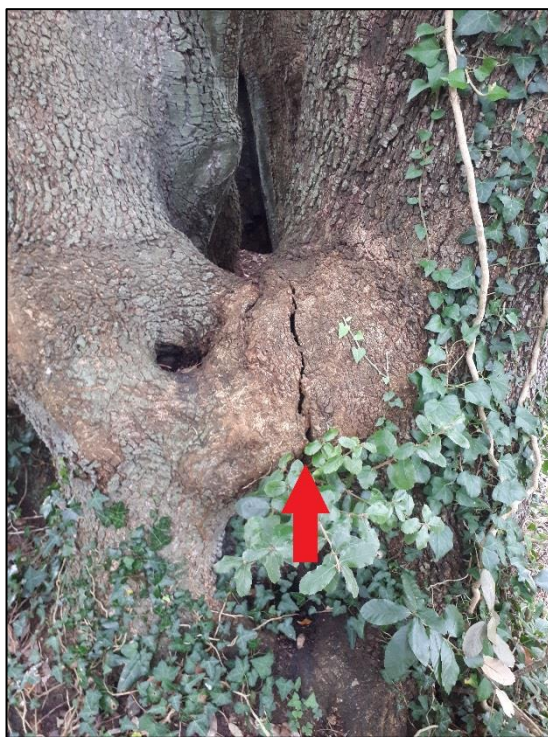
Fig 12. Tree 1019 stem failure

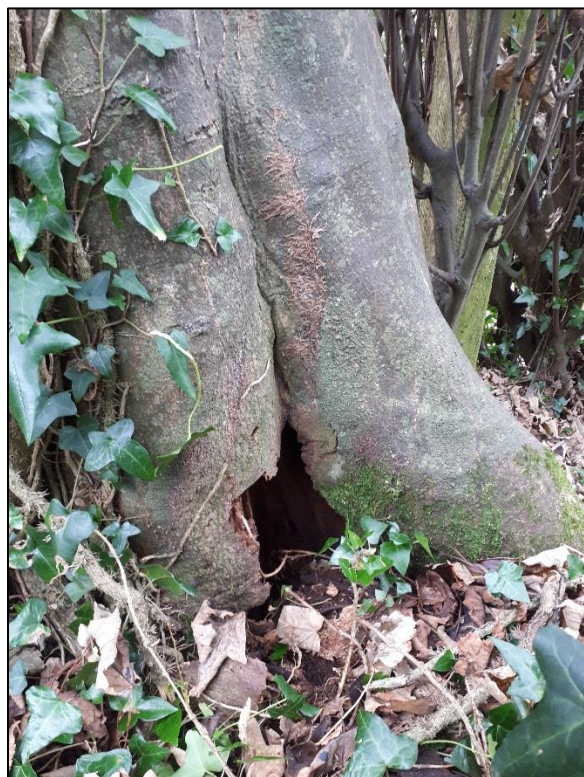
Fig 13. Tree 1027 basal cavity

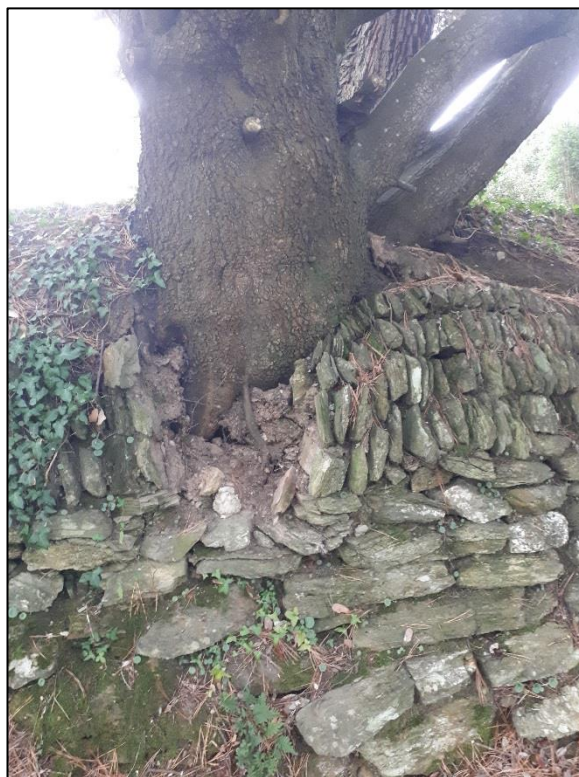
G16	Holm Oak (Quercus ilex)	Y	M	<ul style="list-style-type: none"> Roots damaging structures. N tree has evidence of recent displaced stone face of wall. Not visibly unstable. Stem: tight fork / forks. 	4/Prop/4	<1M Whole tree failure onto gravestones	<ul style="list-style-type: none"> Continue to monitor root system of N tree for signs of instability – works to be undertaken by grounds staff 	ii
G17	Sycamore, Holm Oak, Sessile Oak, Hawthorn, Holly	Y	M	<ul style="list-style-type: none"> Stem: tight fork / forks; Ivy restricted inspection; Ivy. Branches: branch stubs; poorly pruned. 			<ul style="list-style-type: none"> Sever Ivy. 	iv
G18	Sycamore, Elm, Oak	Y	M	<ul style="list-style-type: none"> Stem: Ivy restricted inspection. Unknown ownership. 			<ul style="list-style-type: none"> Sever ivy. Monitor for Elm Disease in summer annually. 	iv
G19	Common Ash (Fraxinus excelsior)	M	L	<ul style="list-style-type: none"> Open cavity: S tree. 400mm gl+ to 1.6m gl+, E side. 400mm wide. Tear wound. Crack in base of stem, S side gl to 200mm gl+. Crown: reduced vitality based on bud distribution. 	3/4/2	500K Deadwood failing onto path.	<ul style="list-style-type: none"> Monitor for ADB symptoms summer 2022. Remove with progressive decline 	ii

Fig 14. G16 soil disturbance at stem base

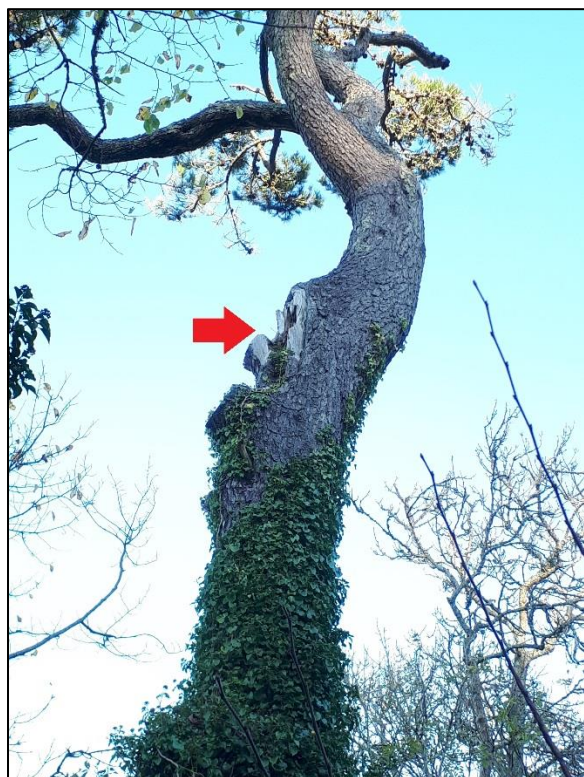
Fig 15. Tree 1036 stem cavity

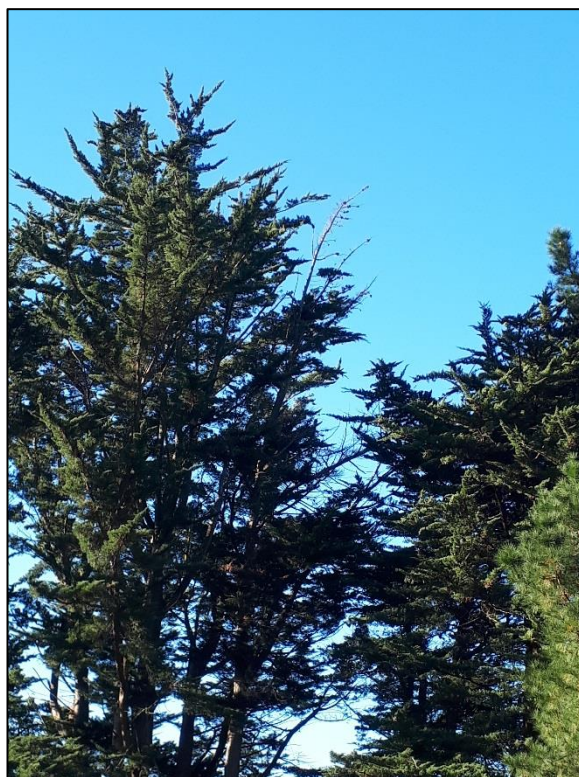
Fig 16. G25 Coryneum Canker dieback

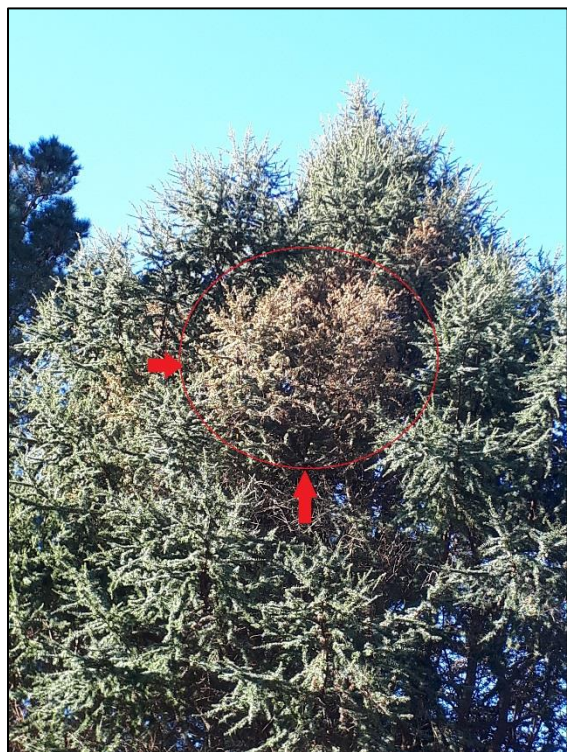
Fig 17. Tree 1043 Siroccocus on Cedar

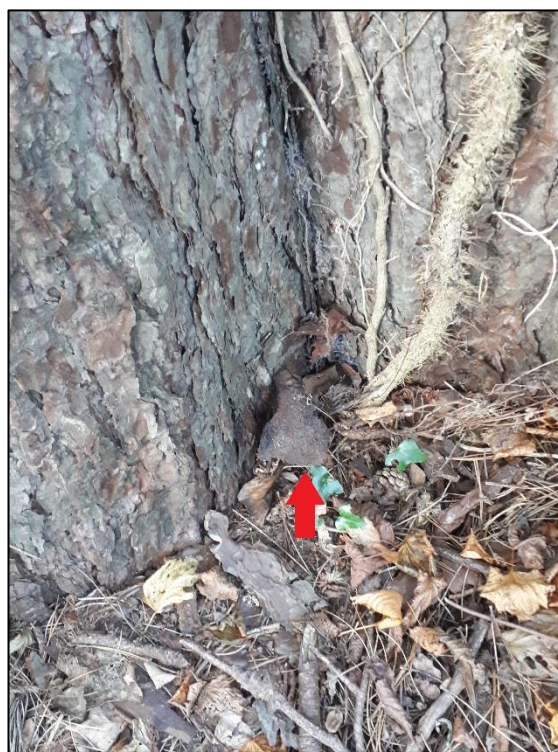
1046	Corsican Pine <i>Pinus nigra</i>	M	L	<ul style="list-style-type: none"> Fungal Fruit Bodies – Basal: <i>Phaeolus schweinitzii</i>. See Fig 18. Basal and lower stem: Fungal fruiting body E side 400mm gl+, S side 100mm gl+. 	2/2/4	100K stem failure onto Madeira Walk and cemetery	<ul style="list-style-type: none"> Undertake detailed investigation using micro-drill to determine extent of basal stem decay 	ii

Fig 18. Tree 1046 Phaeolus schweinitzii

- 5.3.1 Brown rot is caused by fungus preferentially degrading the cellulose within the woody tissues, leaving behind the lignin. Cellulose provides elasticity and flexibility within the wood, whilst the lignin is more akin to the building blocks and is regarded as being more rigid. Browns rots can lead to brittle fracture as the wood becomes

stiffer, but is described as being “infrequently associated with the failure of colonised stems and roots” (Humphries & Wright 2021).

- 5.3.3 Prior to the preparation of this report, Falmouth Town Council has instructed a third-party arboricultural consultant (A.M.Lane) to undertake a detailed investigation of the decay using a micro-drill (Resi PD) to gain further information on the condition of the tree to assist with decision making.
